AudioCodes High Definition IP Phones Series

C470HD C455HD and C435HD IP Phones for Microsoft Teams

Version 2.3.410

Release Notes Contents

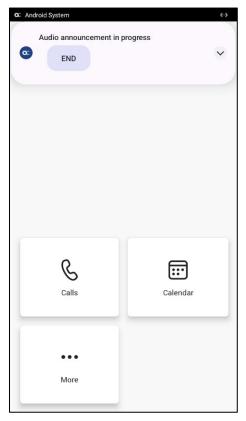
When an incoming call is received on a phone that is in idle, the phone
 immediately automatically answers it, irrespective of whether barge-in is enabled
 or not:

[The screens shown in the figures below are newer than those in the released version. To view them, contact AudioCodes or wait for the next version release.]

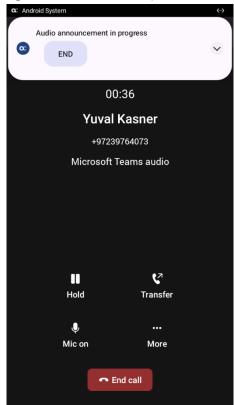
- When the phone is in a Teams call/meeting (active or on-hold):
 - If barge-in is *enabled*, i.e., if the new cfg configuration file parameter voip/services/group_paging/allow_barge_in/enabled=1, then the phone will *automatically immediately* display the **Audio announcement in progress** screen with an option to end the announcement.

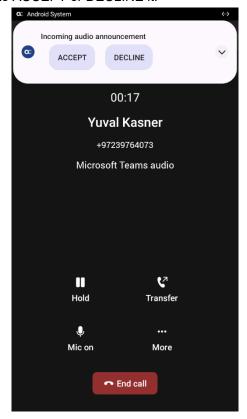
If barge-in is disabled, i.e., if the new cfg configuration file parameter voip/services/group_paging/allow_barge_in/enabled=0, then the phone will display the **Incoming audio announcement** screen with an option to ACCEPT or DECLINE it:

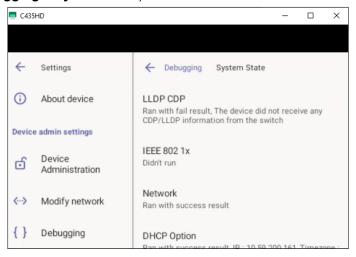
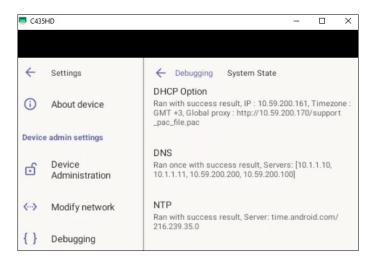
Improved out-of-the-box troubleshooting. Admins can now monitor the status of the various software modules of the device. If initial provisioning is unsuccessful or if admin encounters an issue related to the network / connection to Device Manager, the feature gives admin an indication as to why.

The feature enables debugging via the phone screen without requiring external systems. Admin can check connectivity independently of external apps. The figure below shows the new System State screen that has been added (**Settings** > **Debugging** > **System State**).

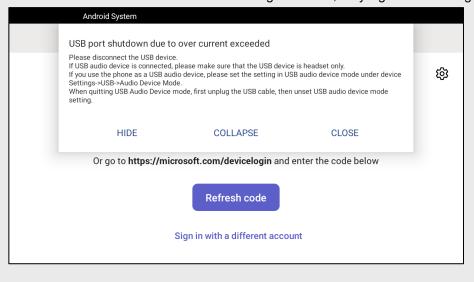
- It is important to set the feature up *in this order* (first enable USB device mode and then connect the USB cable).
- If the user connects the cable *before* enabling the mode, they'll get this message:

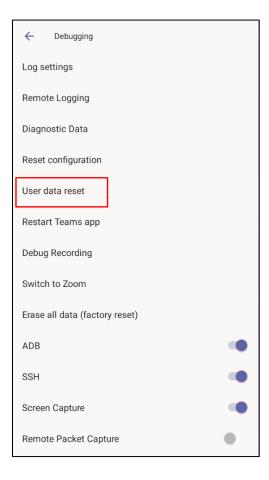
- TYPE_HEADSET (regular headset)
- TYPE_RJ9_HEADSET
- AudioCodes Teams devices now provide a new User data reset option that is similar to factory reset except that the new option preserves predefined data after firmware upgrade. Admins can access the functionality in the phone's user interface by navigating to Device administration > Debugging > User data reset.

The figure below shows the C470HD phone's user interface.

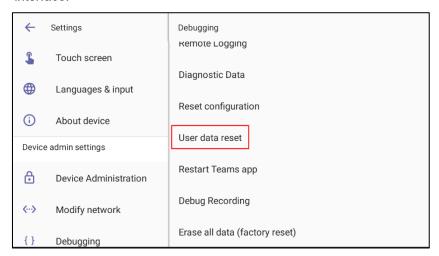
The figure below shows the C435HD \mid C450HD \mid C455HD phone user interface.

After 'User data reset', network settings are preserved.

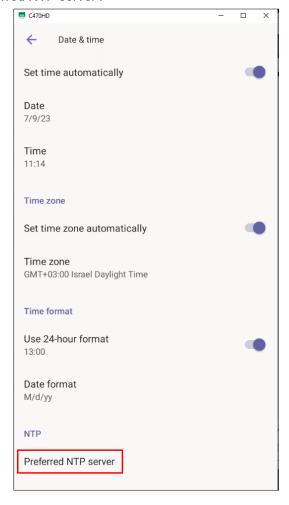
Two ways to manually define the NTP server are available:

• Admins can define it in the phone's GUI using the newly added parameter 'Preferred NTP server'.

Admins can alternatively use the newly added parameter date_time/ntp/server_address in the phone's .cfg configuration file.

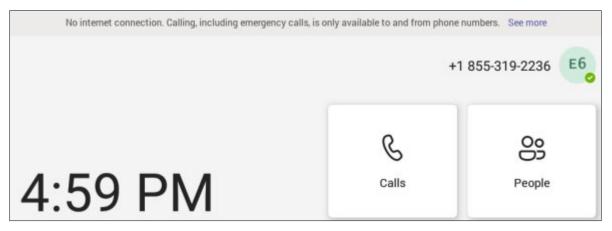
A 'No internet connection' indication is displayed suggesting that calling a phone number is available.

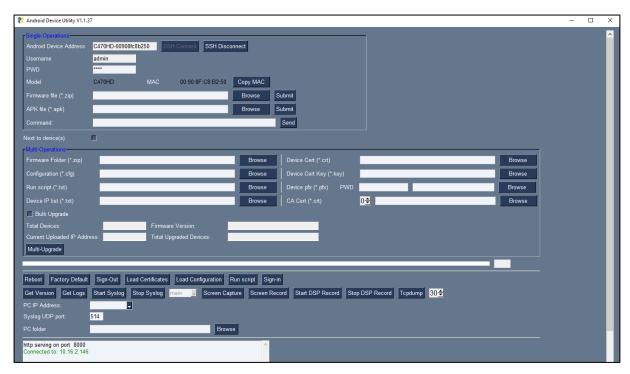
AudioCodes Android Device Utility: If the enterprise IT admin doesn't know the device's IP address, they can nonetheless connect to it using host name, e.g., <model>-<mac> or C470HD-00908fc8b250 as shown in the figure below.

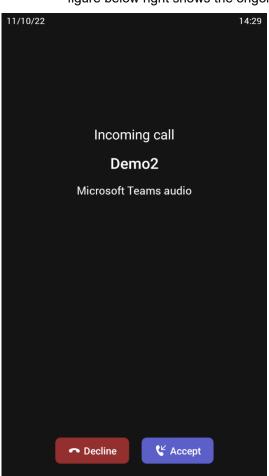
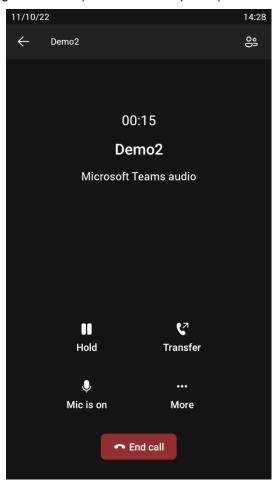
Microsoft Lightweight Calling Experience. AudioCodes' phones now feature a simplified look and feel for incoming and outgoing calls, with improved performance. This new capability is enabled by default. It can be disabled from the phone screen (Teams Application Settings > Calling > Enable lightweight calling experience).

The figure below left shows an incoming call screen (on the C470HD phone) while the figure below right shows the ongoing call screen (on the C470HD phone).

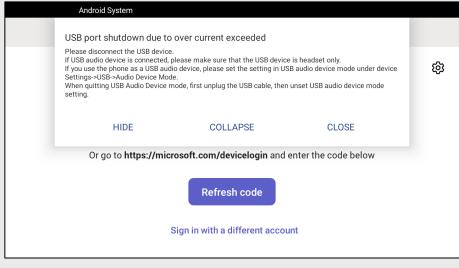
Note: It is important to set the feature up in this order (first enable USB mode and then connect the USB cable). If the user connects the cable before enabling the mode, they'll get this message: Android System

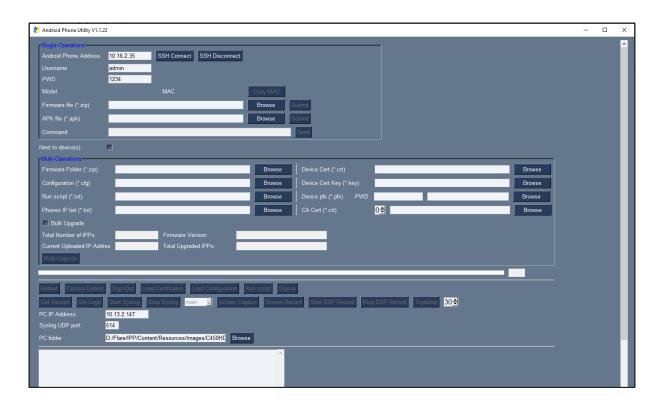
- AudioCodes' Android Phone Utility management application has been updated to version 1.1.27, including a name change (it was previously Teams IP Phone Utility). Updates include:

- A new drop-down allowing network administrators to take screenshots of the phone's Expansion Module (sidecar) (C450HD models or C455HD models). By default, the field indicates 'main', i.e., the phone's main screen.

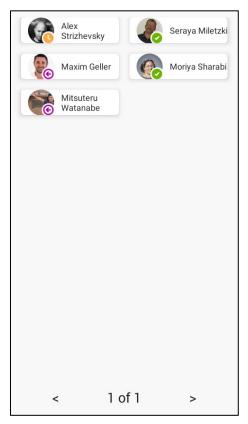
The figure below shows an example of a screenshot of the Expansion Module (sidecar).

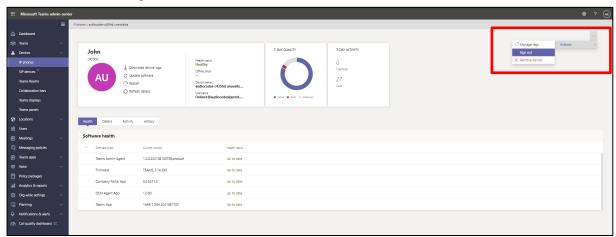
- Upgrade to Microsoft Teams application version 2021101205
- Upgrade to Microsoft Company Portal application version 5.0.5304.0
- Upgrade to Microsoft Admin Agent application version 298
- Moving between the phone's 'home' screen and the tabs (Calls, Calendar, People, Voicemail) has been optimized and it now performs faster.
- Remote sign out can be performed from Microsoft Teams admin center (TAC). Network administrators can provision devices from the TAC, remotely sign in, and now also sign out from devices.

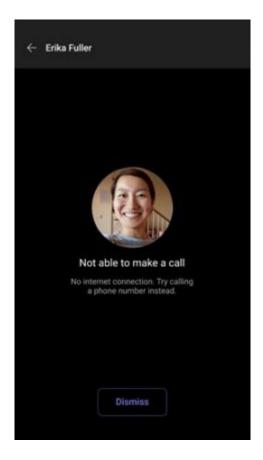
If a user attempts to make a Teams call and the internet connection is down, they'll be notified that they can try calling a phone number instead.

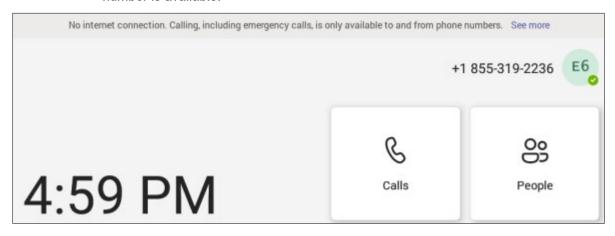
A 'No internet connection' indication is displayed suggesting that calling a phone number is available.

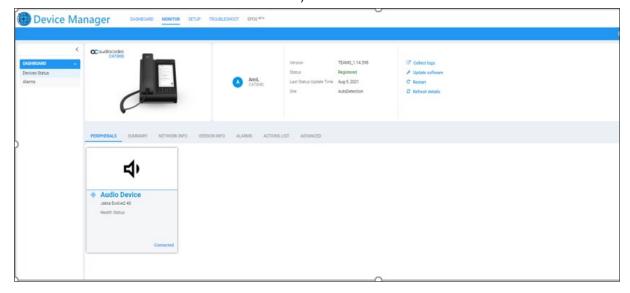
- AudioCodes' Device Manager features new capabilities for the Teams phones:
 - Connected peripheral devices are displayed in a dedicated new Show Info screen. Network administrators can navigate to the screen via the Show Info menu option (Monitor > Dashboard > Devices Status and then click the button Actions = next to the device).

The Show Info screen displays all information related to the device needed by the network administrator. The **Peripherals** tab is displayed (by default) if a peripheral such as a headset is connected, as shown in the previous figure. All information that the peripheral device sends to the OVOC as raw data composes the Peripherals screen.

For the feature to function, network administrators must make sure that the parameter 'dm/report_status/paths' exists in the device's template in the Device Manager (it's part of the default template); the value that must be configured for this parameter needs to be status/audio/stream/*, status/network/wifi/mac, status/installed/*, status/peripheral/device/*

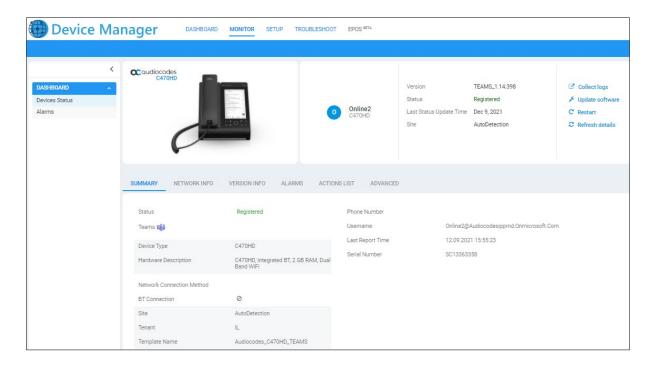
- Valid values are:
 - status/audio/stream/*
 - status/network/wifi/mac
 - status/installed/*
 - status/peripheral/device/*
- Information related to the device's version is displayed under the Version Info tab in the Show Info screen. Network administrators can navigate to it via Monitor > Dashboard > Devices Status and then clicking Actions ≡ next to the listed device and selecting Show Info).

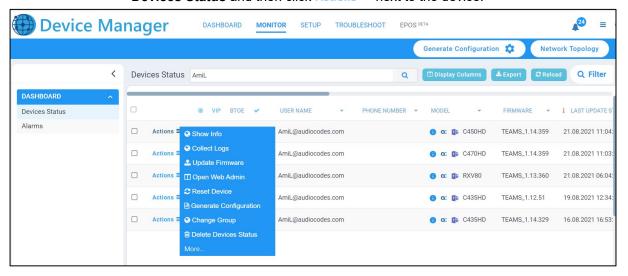
Network administrators can get logs from devices for debugging purposes without needing to go to the device The Collect Logs option in AudioCodes' Device Manager, shown in the next figure, allows this. Network administrators can navigate to the option via Monitor > Dashboard > Devices Status and then click Actions ≡ next to the device.

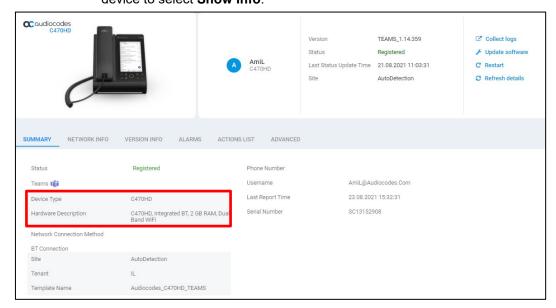
Information related to the device's hardware specification is now displayed under the Summary tab in the Device Manager's Show Info screen. Network administrators can navigate to the Show Info screen via Monitor > Dashboard > Devices Status and then click Actions = next to the device to select Show Info.
